TEST RESULTS: (CONT'D)

PHOTOS TAKEN ON WINDOW #2 WITH ONE PAIR OF SAFETY DEVICES

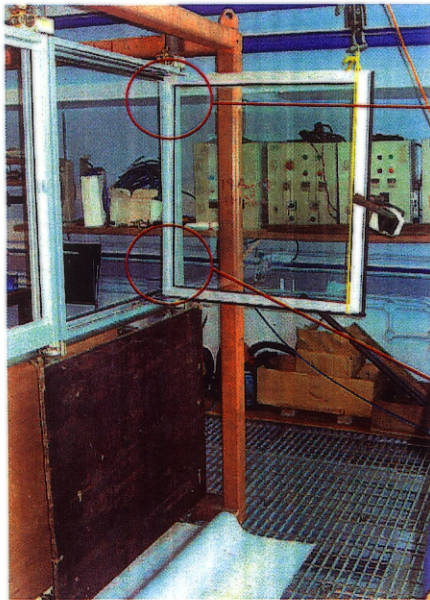
Photo 3: Window #2 with one pair of safety devices – initial test setup

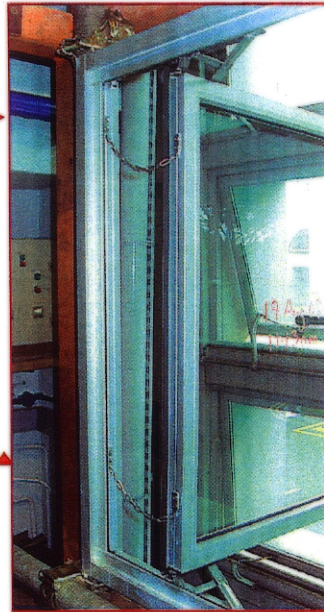
One pair of safety devices close-up view

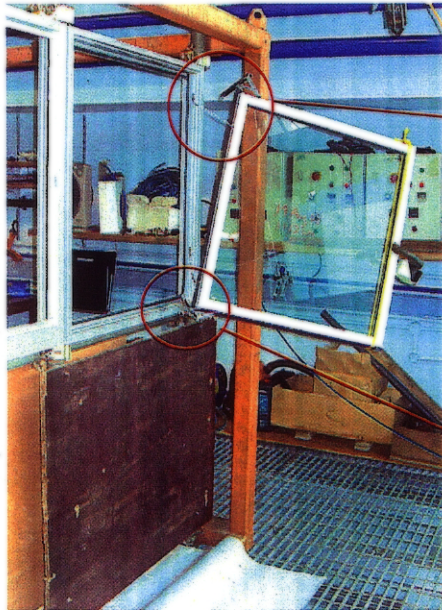
Photo 4: After the fall, the sash remain intact on the outer frame for the next 24 hours.

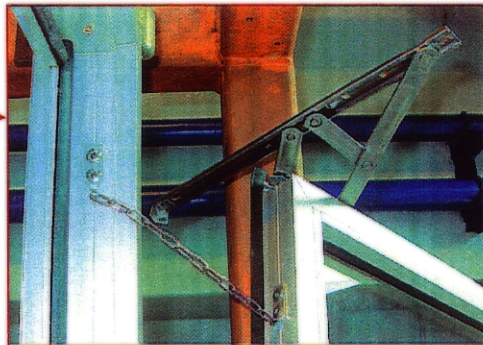
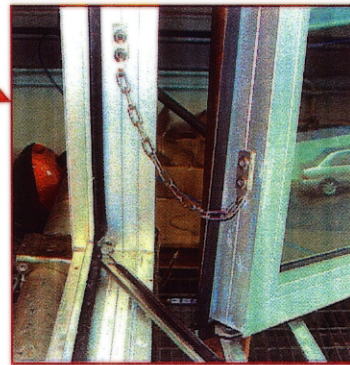
Close-up view of
safety devices
after the fall
